Manhole Inspection Summary

Manhole # S41U__029MH

Insp Date: **2/25/09 10:20 AM**

Location Address: **1401 woodall st**

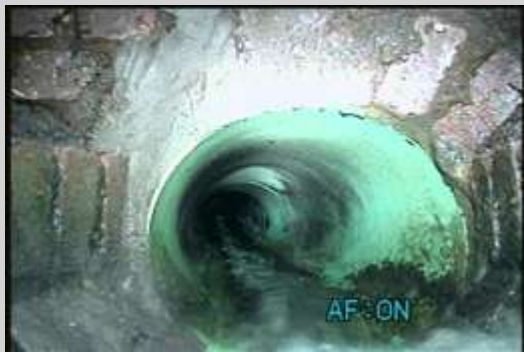
12 O'Clock Outflow

12 in. Circular Gravity Sewer
Pipe Out @ 12 O'Clock

Pipe Material: **PVC** ☐ Pipe Lined

Invert Depth: **8.16** (ft.) Flow Characteristics: **Fast**

Deposits: ☒ None ☐ Mud ☐ Sludge ☐ Debris ☐ Grease

Infiltration: **None** Pipe Seal Cond: **Unknown**

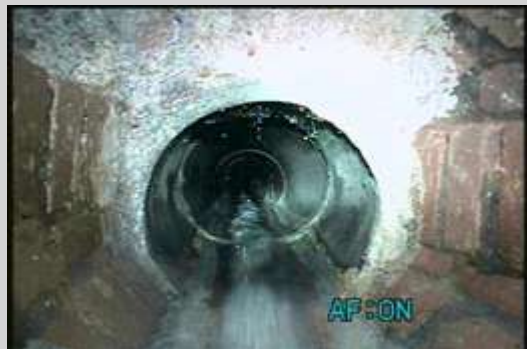
9 O'Clock Inflow

8 in. Circular Gravity Sewer
Pipe In @ 9 O'Clock

Pipe Material: **Clay** ☐ Pipe Lined

Infiltration: **None** Pipe Seal Cond: **Unknown**
